Knowledge-based specification of products combined with a solid maintenance plan reduces downtime at infant formula manufacturing plant.

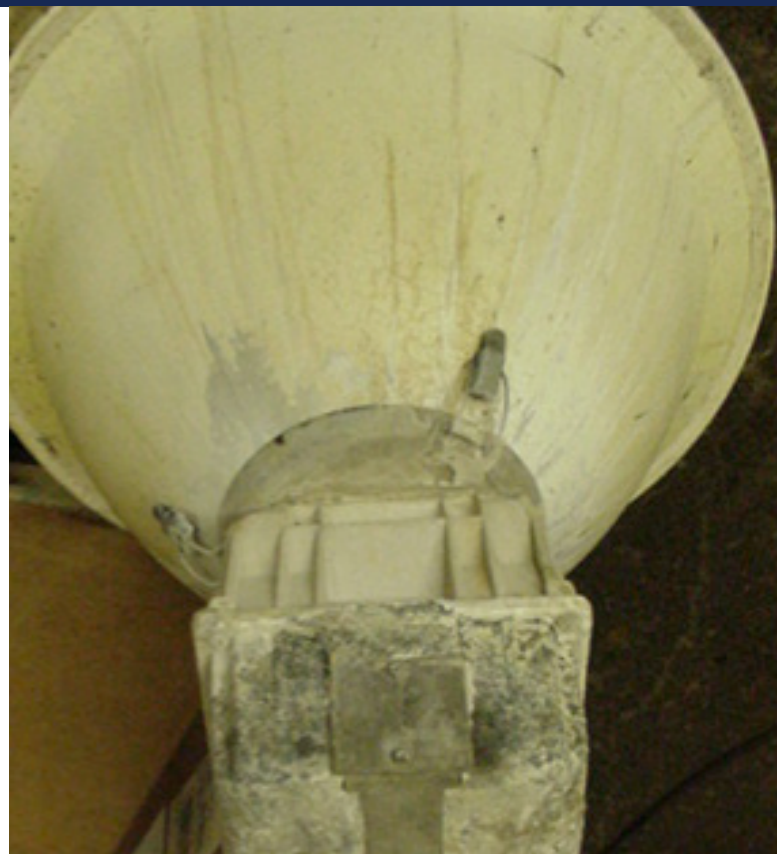
Corrosion discovered on lighting fixture by an electrical engineer in a food manufacturing plant shortly after graduation from Corrosion College. Immediate replacement of the fixture eliminated any potential danger of corrosion flakes falling into the food being processed directly below.

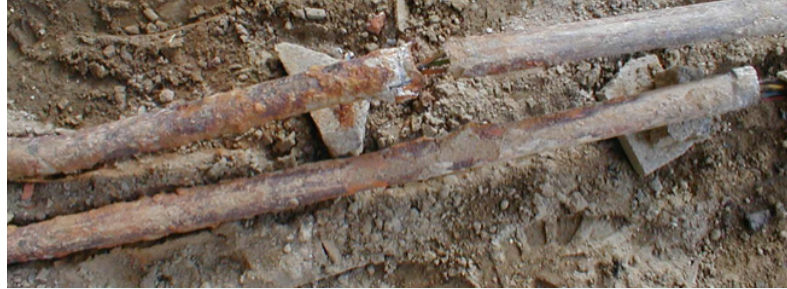
Rigid metal conduit placed underground at a renovation of a convenience store with fueling islands, it was revealed that the conventional conduit that runs to the pumps had suffered greatly from corrosion. To learn more about corrosion and how to eliminate the cost associated with replacement of product due to failure – attend Corrosion College.

“As an Electrical Inspector, I have found several instances of evidence of corrosion in underground installations. This intrigued me as to why some areas were subjected to this deleterious effect and others were not. In particular, at a renovation of a convenience store with fueling islands, it was revealed that the conventional conduit that runs to the pumps had suffered greatly from corrosion. Enough damage had occurred that a definite hazardous condition existed. It was determined that some seven years earlier a leaking underground fuel tank had contaminated the surrounding area. It was replaced and the site was deemed clean. When using conduit for underground burial, you always run the risk of corrosion due to the fact that the conduit is in two different environments (underground and above ground), which also means it is in two different electrolytes. This causes corrosion to occur naturally, but the fact that there were additional chemicals introduced into the environment made it that much worse.”

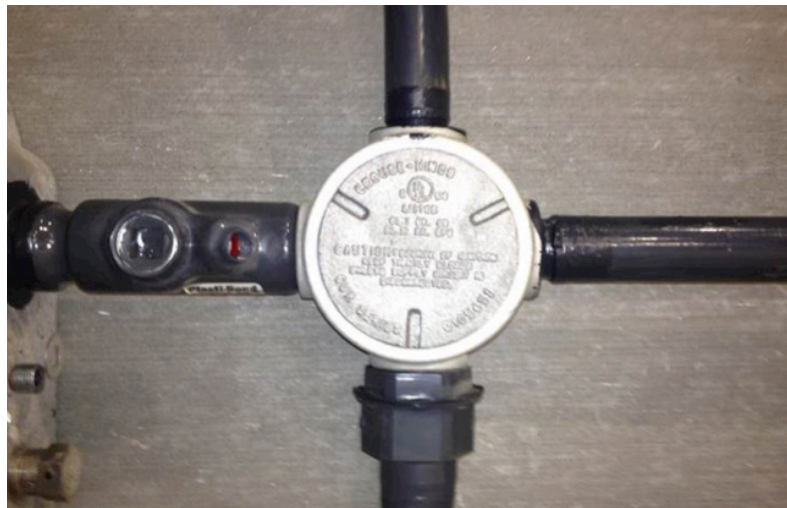
This PVC Coated Conduit was installed with an uncoated GUA fitting, which could compromise the performance of the installation. When installing PVC Coated Conduit it is important to create a sealed system. Knowledge of PVC-Coated Conduit regulations and proper installation is essential for success of a project. Graduation from Corrosion College ensures your project will succeed in a corrosive environment.
